Independent Investigation Report of the November 2005 Drum Fire at the Idaho National Laboratory Site

**Independent Investigation Report of the
November 2005 Drum Fire at the
Idaho National Laboratory Site**

**Idaho Cleanup Project
Radioactive Waste Management Complex
Idaho Falls, Idaho 83415**

RPT-190

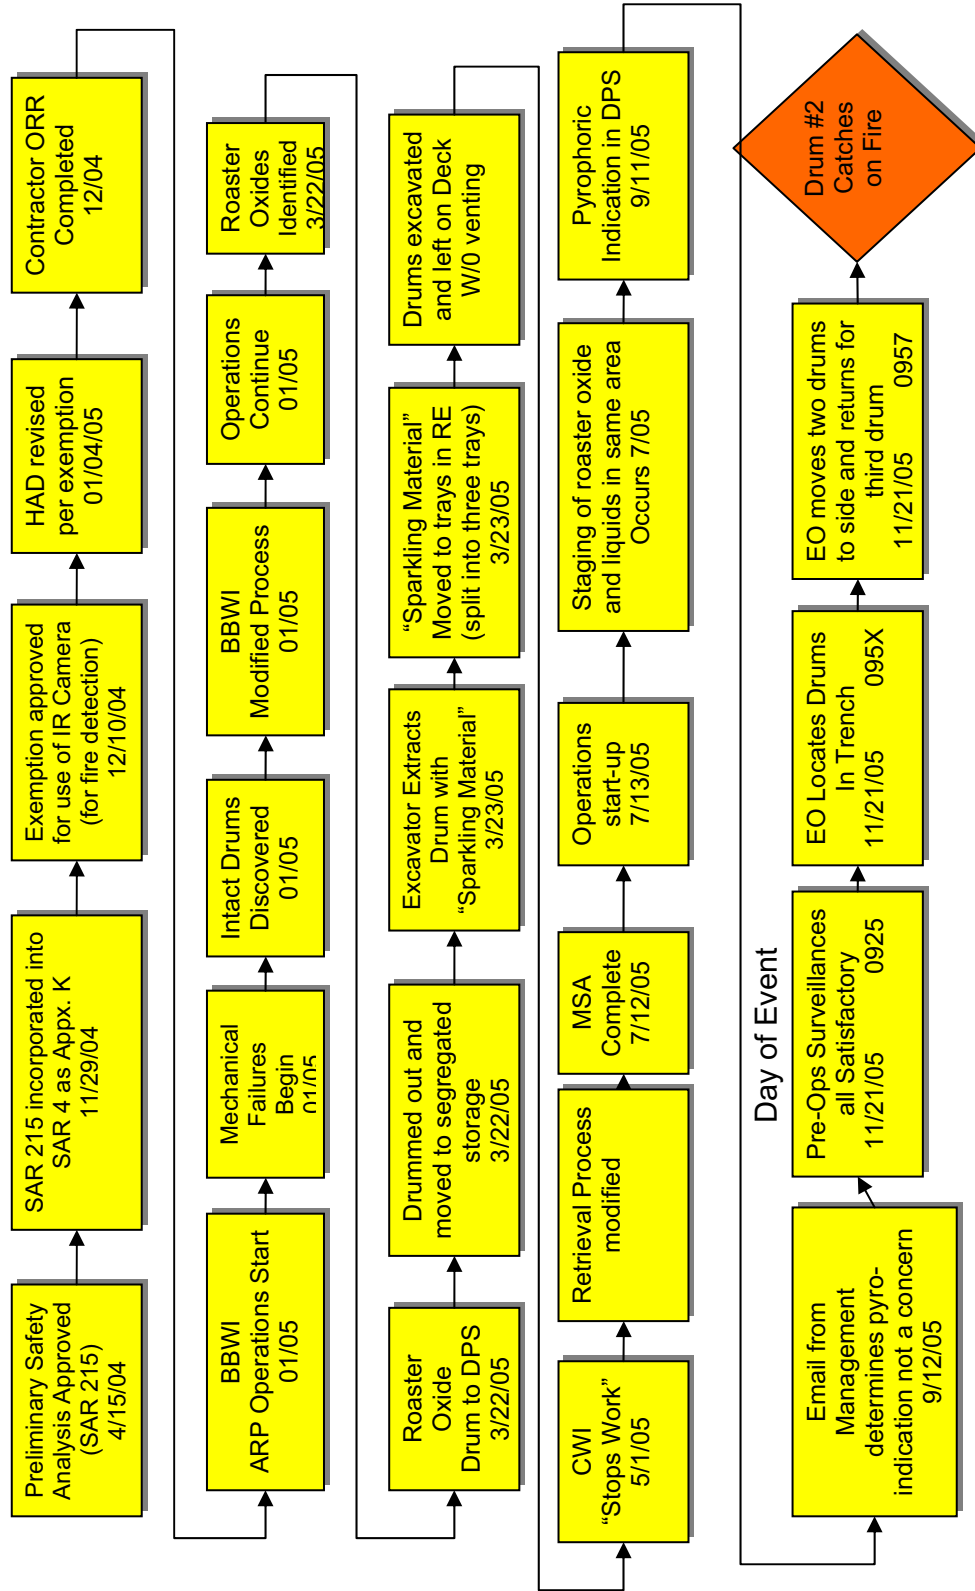
Figure 19. Timeline of pre-fire events.

To identify additional potential organizational and process weaknesses, the team reviewed the project history. The timelines in Figures 19 and 20 outline what the team considered to be significant events relative to this fire. The events that indicate organizational and/or process weaknesses are discussed in more detail in the subsequent pages of the report. If the project had conducted more in-depth evaluation of some of these events when they occurred, the project might have identified the increased potential for a drum deflagration. However, the team concludes that even if the process weaknesses had been corrected before opening this drum, the drum would still have undergone a rapid pyrophoric reaction when opened.
